L636-
A.03.19

To: Official After-Sales Network
Subject: Fender's brackets screws replacement
Date: 22 February 2019
Pages 3

Campaign Name:
Front fender's brackets screws replacement

Model:
Urus

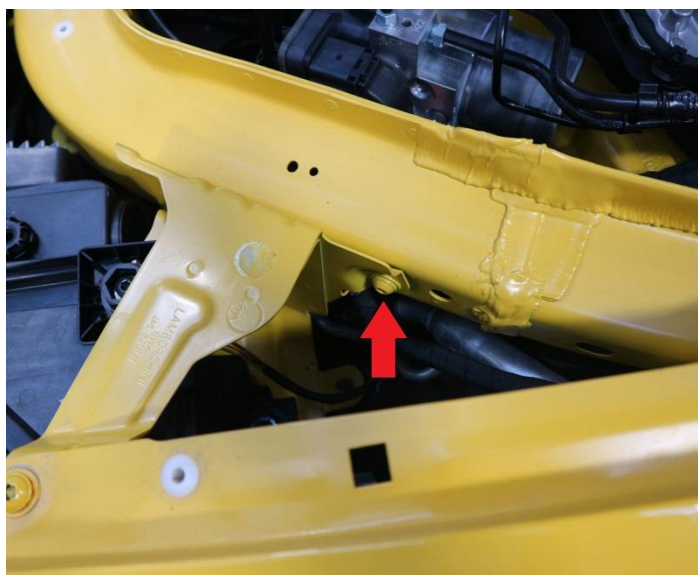
As a result of continuous product monitoring, Automobili Lamborghini Spa has determined that it is necessary to replace 2 screws on the front fender's brackets.

2. Replace the screw (N91166901) shown in the figure with the screw (N91132602), using SCH02225 primer.

Tighten the screw.

Tightening torque: **10 Nm (7,38 lbf ft)**

Repeat the same operation for the right side.
